*Early Prosthetic Loading of STERI-OSS Implant
Clinical Outcomes and Osseointegration Assessment*

by Dr. Lee, Daehee, DDS, MSD, Ph.D

STERI-OSS IMPLANT

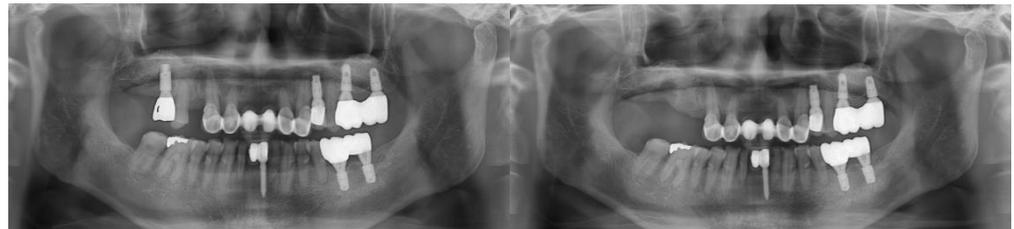
Panoramic radiograph: Tooth #15 - vertical mobility, Tooth #16 - screw loosening of pre-placed implant. Extraction and the implant removal were performed.

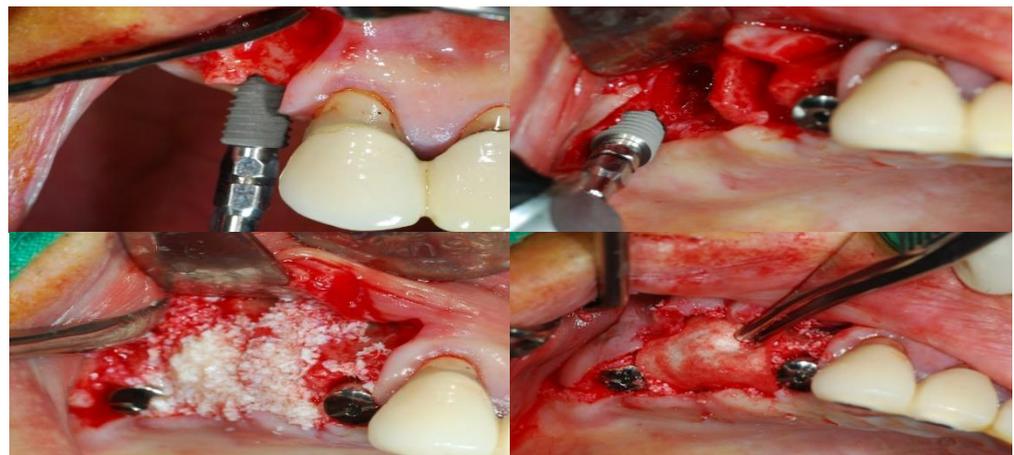
STERI-OSS Implants (SD4508 and SD5007) were placed. The site was grafted with Xenograft material and collagen membrane was engaged between the grafting material and soft tissue.

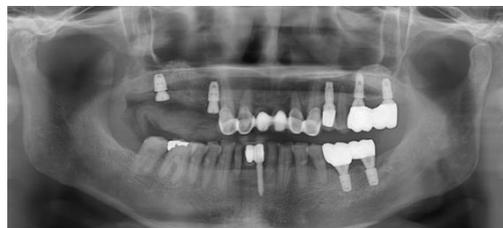
Panoramic radiograph: Initial Implantation at #14(SD4508), #16(SD5007) in March 2019

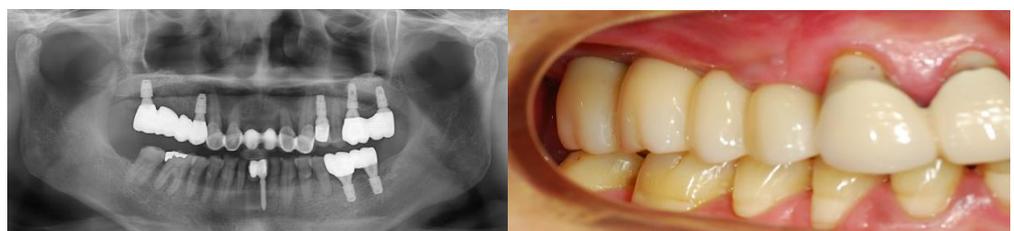
Panoramic radiograph: Recall check in April 2021

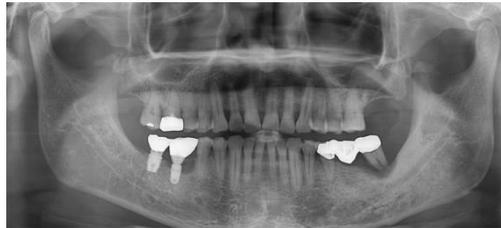
Panoramic radiograph: Peri-implantitis occurred at site #46, and periodontitis developed at site #37

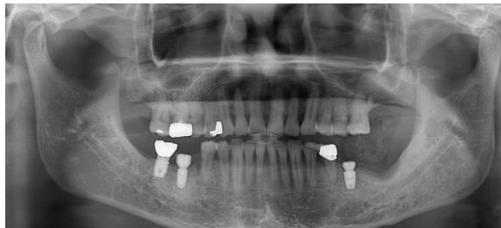
Panoramic radiograph: Initial Implantation at #36(SD5007) in April 2019

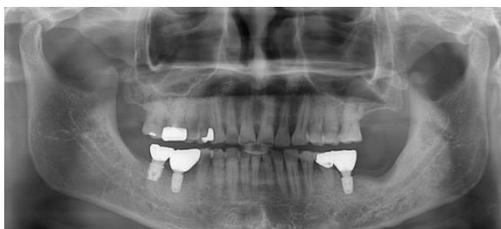
Panoramic radiograph: Recall check in March 2021

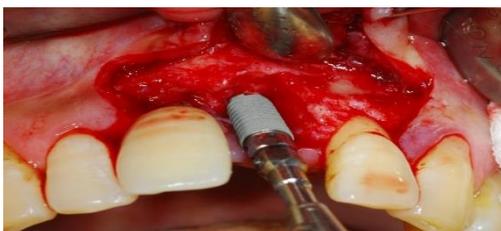
STERI-OSS Implant (SD4010) was placed.

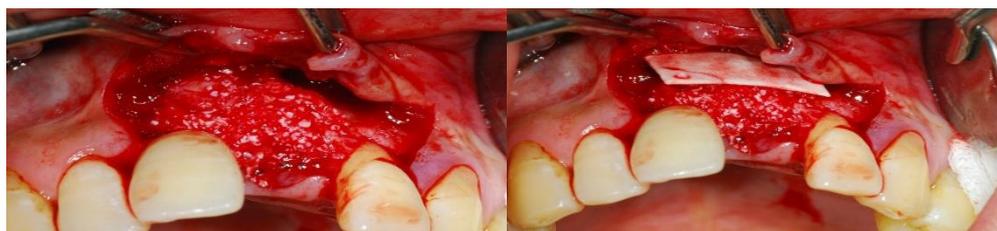
The site was grafted with Xenograft material and collagen membrane was engaged between the grafting material and soft tissue.

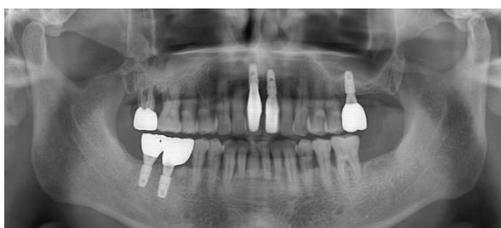
Panoramic radiograph: Recall check in May 2021

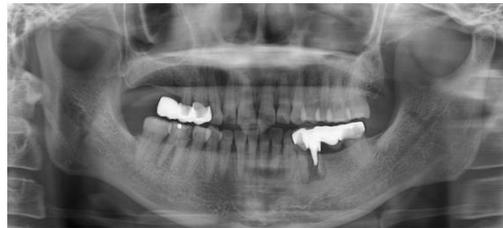
Panoramic radiograph: tooth #35 had a root fracture, and tooth #46 had severe dental caries along with a crack in the distal root.

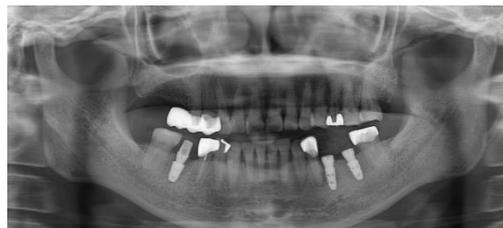
Panoramic radiograph: Initial Implantation at #35(SD4010), #37(SD4508), #46(SD5008) in June 2019

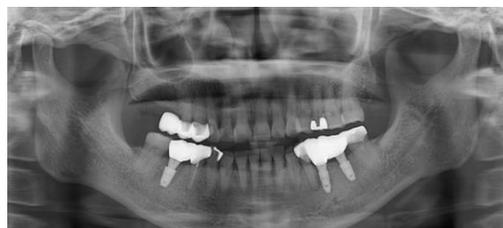
Panoramic radiograph: Recall check in April 2021

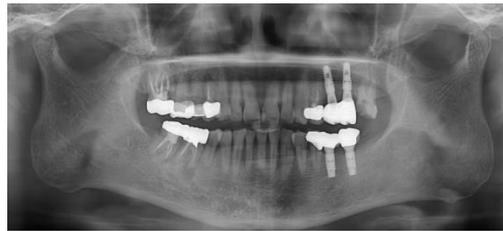
Panoramic radiograph: #46 tooth is in a severe state of apical inflammation.

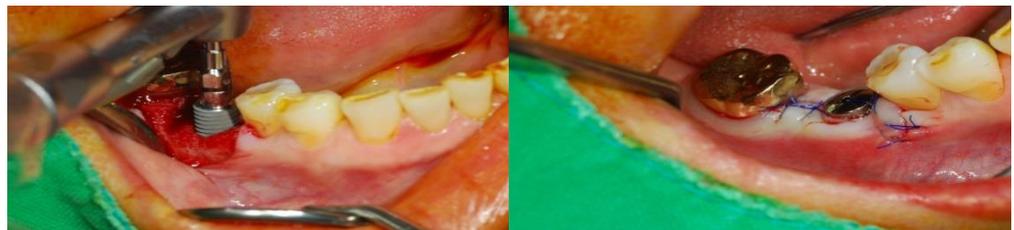
STERI-OSS Implant (SD5007) was placed.

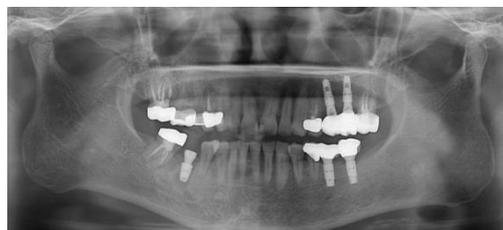
Panoramic radiograph: Initial Implantation at #46(SD5007) in May 2019

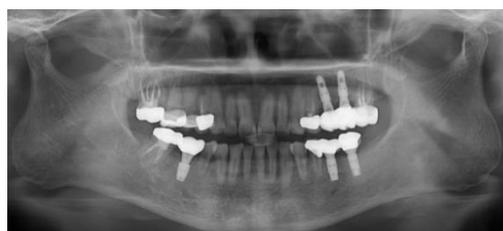
Panoramic radiograph: Recall check in March 2021

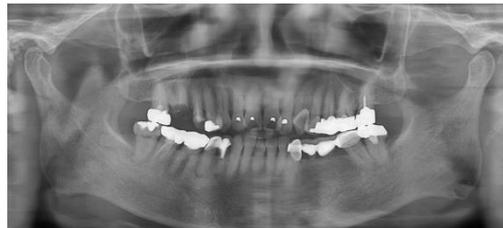
Panoramic radiograph: A patient with a fractured tooth #16

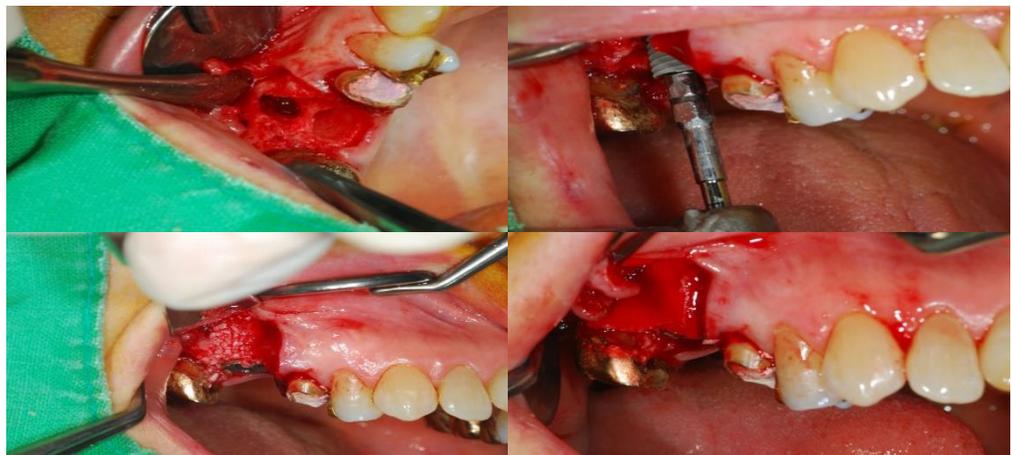
#16 extracted and STERI-OSS Implant (SD5008) was placed. Bone grafting and collagen membrane were engaged.

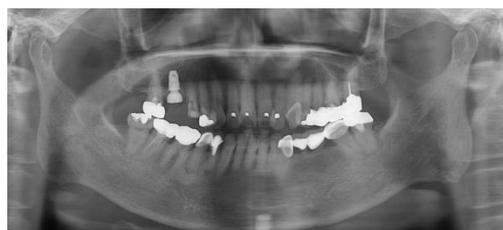
Panoramic radiograph: Initial Implantation at #16(SD5008) in March 2019

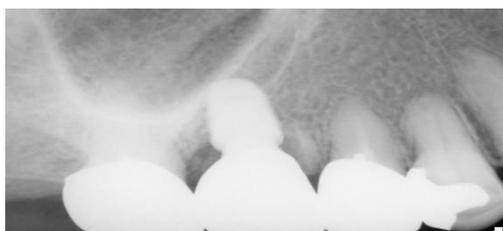
Panoramic radiograph: Recall check in February 2021

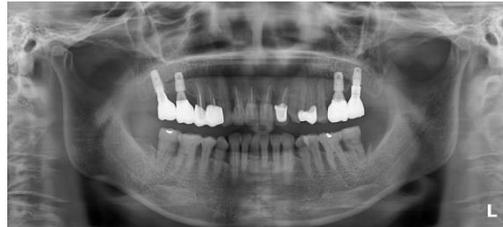
Panoramic radiograph: #37 has severe cervical caries.

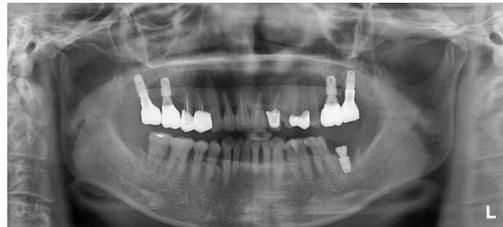
Panoramic radiograph: Initial Implantation at #37(SD5007) in September 2019

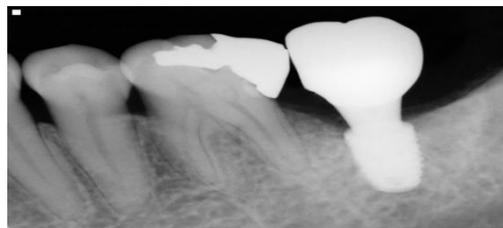
Panoramic radiograph: Recall check in October 2020

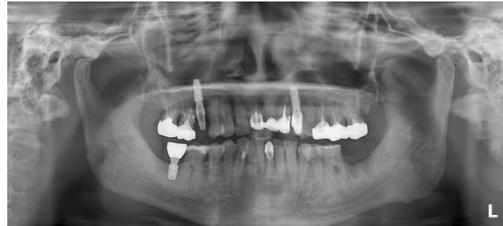
Panoramic radiograph: A patient presenting with a missing #37 tooth.

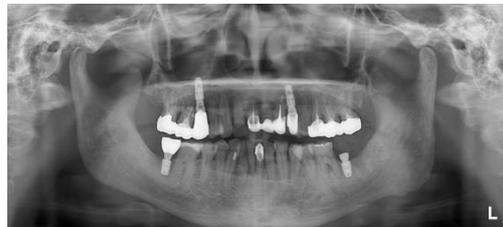
Panoramic radiograph: Initial Implantation at #37(SD5007) in April 2019

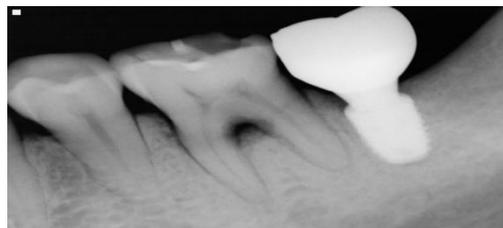
Panoramic radiograph: Recall check in April 2021

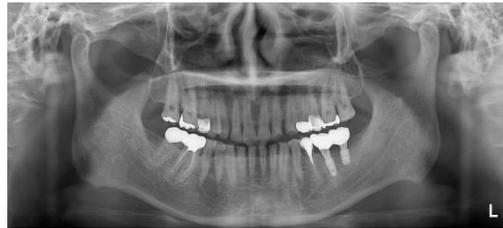
Panoramic radiograph: A fractured post crown at #35

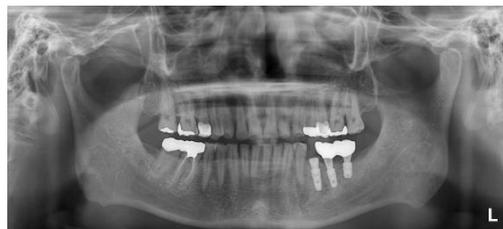
Panoramic radiograph: Initial Implantation at #35(SD4510) in May 2019

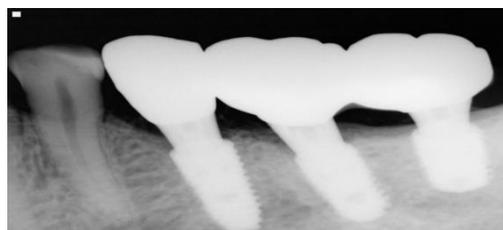
Panoramic radiograph: Recall check in February 2021

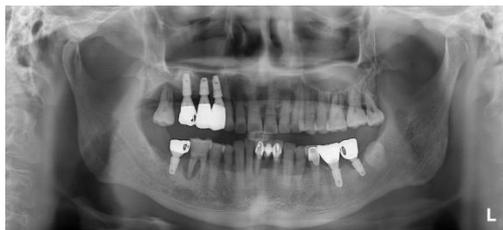
Panoramic radiograph: Tooth #46 is in a severe periodontitis condition.

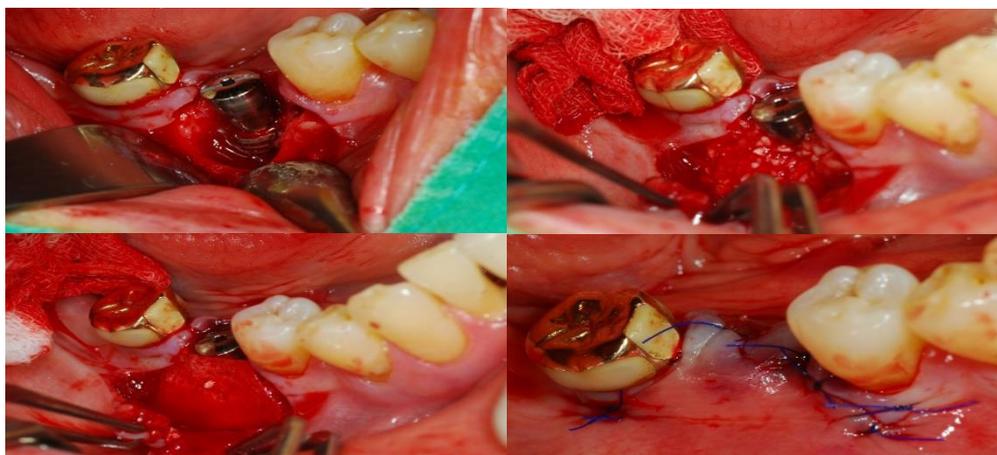
STERI-OSS Implant (SD5007) was placed, followed by bone grafting and membrane engaged.

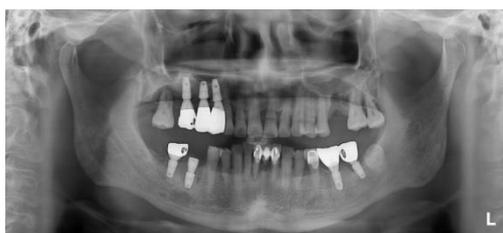
Panoramic radiograph: Initial Implantation at #46(SD5007) in February 2019

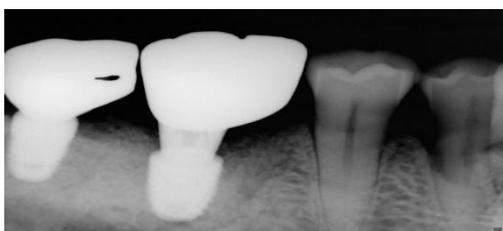
Panoramic radiograph: Recall check in April 2021

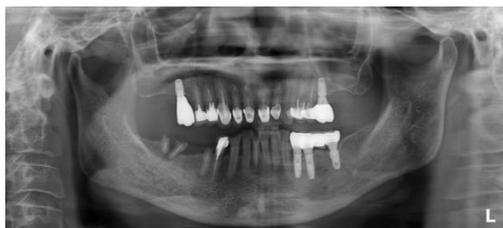
Panoramic radiograph: A patient presenting with only the roots of the tooth remaining.

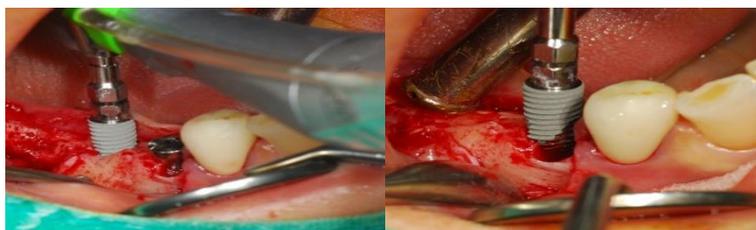
STERI-OSS Implants (SD4510 and 4508) were placed.

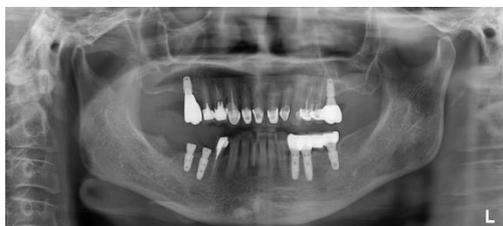
Panoramic radiograph: Initial Implantation at #46(SD4510) and #47(SD4508) in July 2019

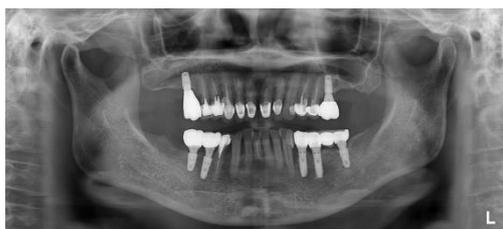
Panoramic radiograph: Recall check in March 2021

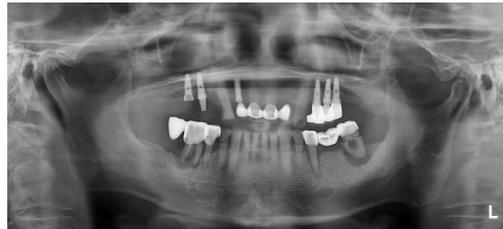
Panoramic radiograph: A patient presenting with severe periodontitis in both the left and right mandible.

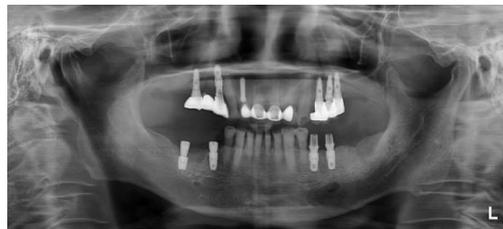
Panoramic radiograph: Initial Implantation at #45(SD4508) and #47(SD5006) in February 2020

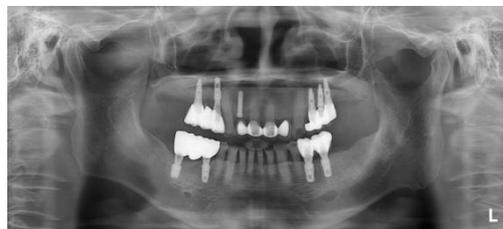
Panoramic radiograph: Recall check in May 2021

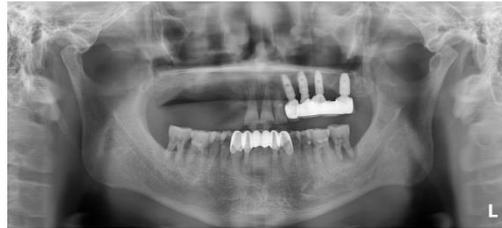
Panoramic radiograph: The right maxilla has a very low bone volume.

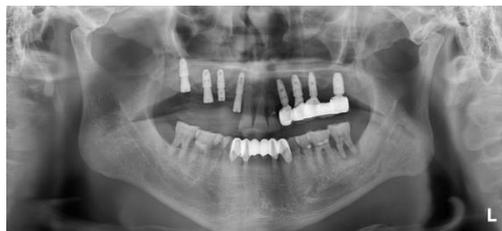
Panoramic radiograph: Initial Implantation at #15(SD4508), #17(SD4508) in March 2020

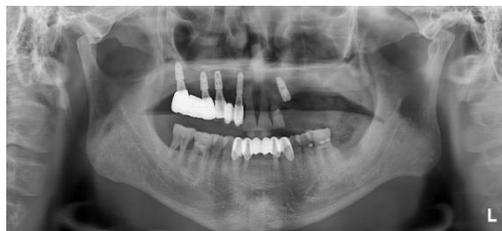
Panoramic radiograph: Recall check in May 2021
